Manhole Inspection Summary

Manhole # S33G__028MH

Record Plat: **33G** Node: **028** Status: **Found**

Location Address: **1 w baltimore st**

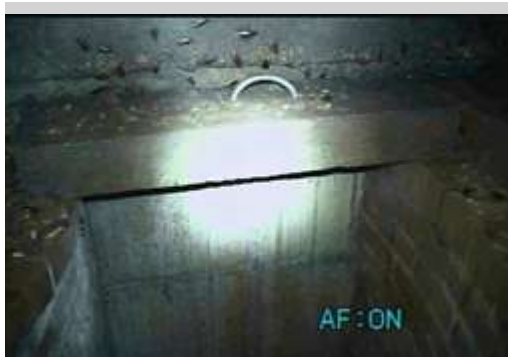
top view of left 12 pipe

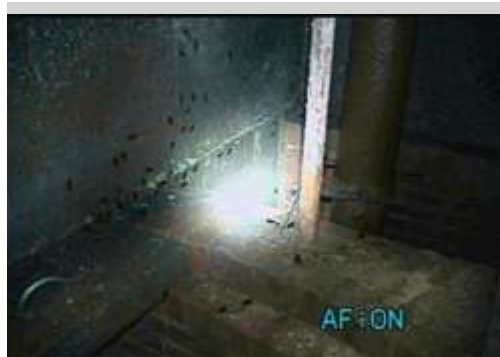
Comments **Has two channels for two out pipes at 12**

has 2 out pipes

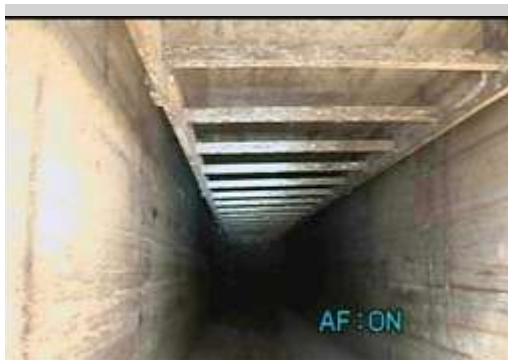
Defect 2

Steps Count: **0** Missing: **0** ☒ **Corroded**

Corroded ladder

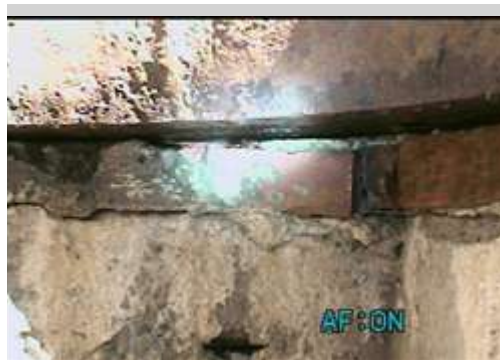
Defect 1

Condition: ☐ Sound ☒ **Cracked** ☐ Root Intrusion ☒ **Loose Brick** ☒ **Deteriorated**

Corbel Cracked, Deteriorated with Loose Bricks

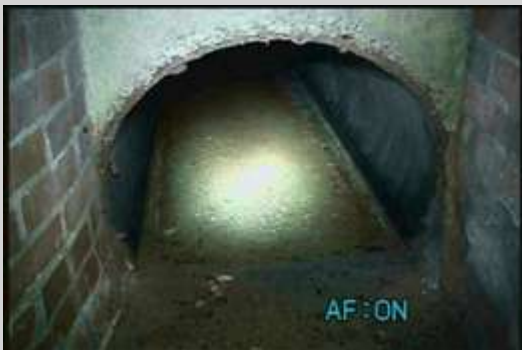
12 O'Clock Outflow

24 in. Circular Gravity Sewer
Pipe Out @ 12 O'Clock

Pipe Material: **Clay** ☐ Pipe Lined

Invert Depth: **28.00** (ft.) Flow Characteristics: **None**

Infiltration: **None** Pipe Seal Cond: **Unknown**

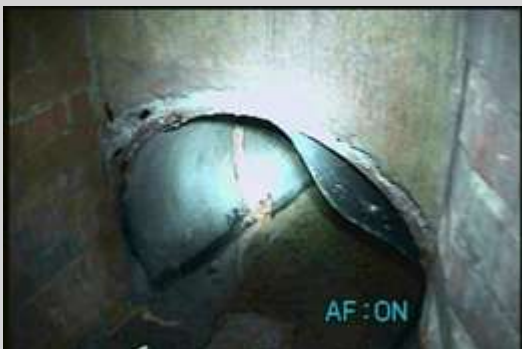
9 O'Clock Inflow

24 in. Circular Gravity Sewer
Pipe In @ 9 O'Clock

Pipe Material: **Clay** ☐ Pipe Lined

Invert Depth: **27.00** (ft.) Flow Characteristics: **None**

Infiltration: **None** Pipe Seal Cond: **Unknown**
